The Road to Sayed: Lessons Learned From a Recovery Operation in Northern Afghanistan

BY CAPTAIN ANDREW J. FAIR AND FIRST LIEUTENANT PHILIP MESSINA

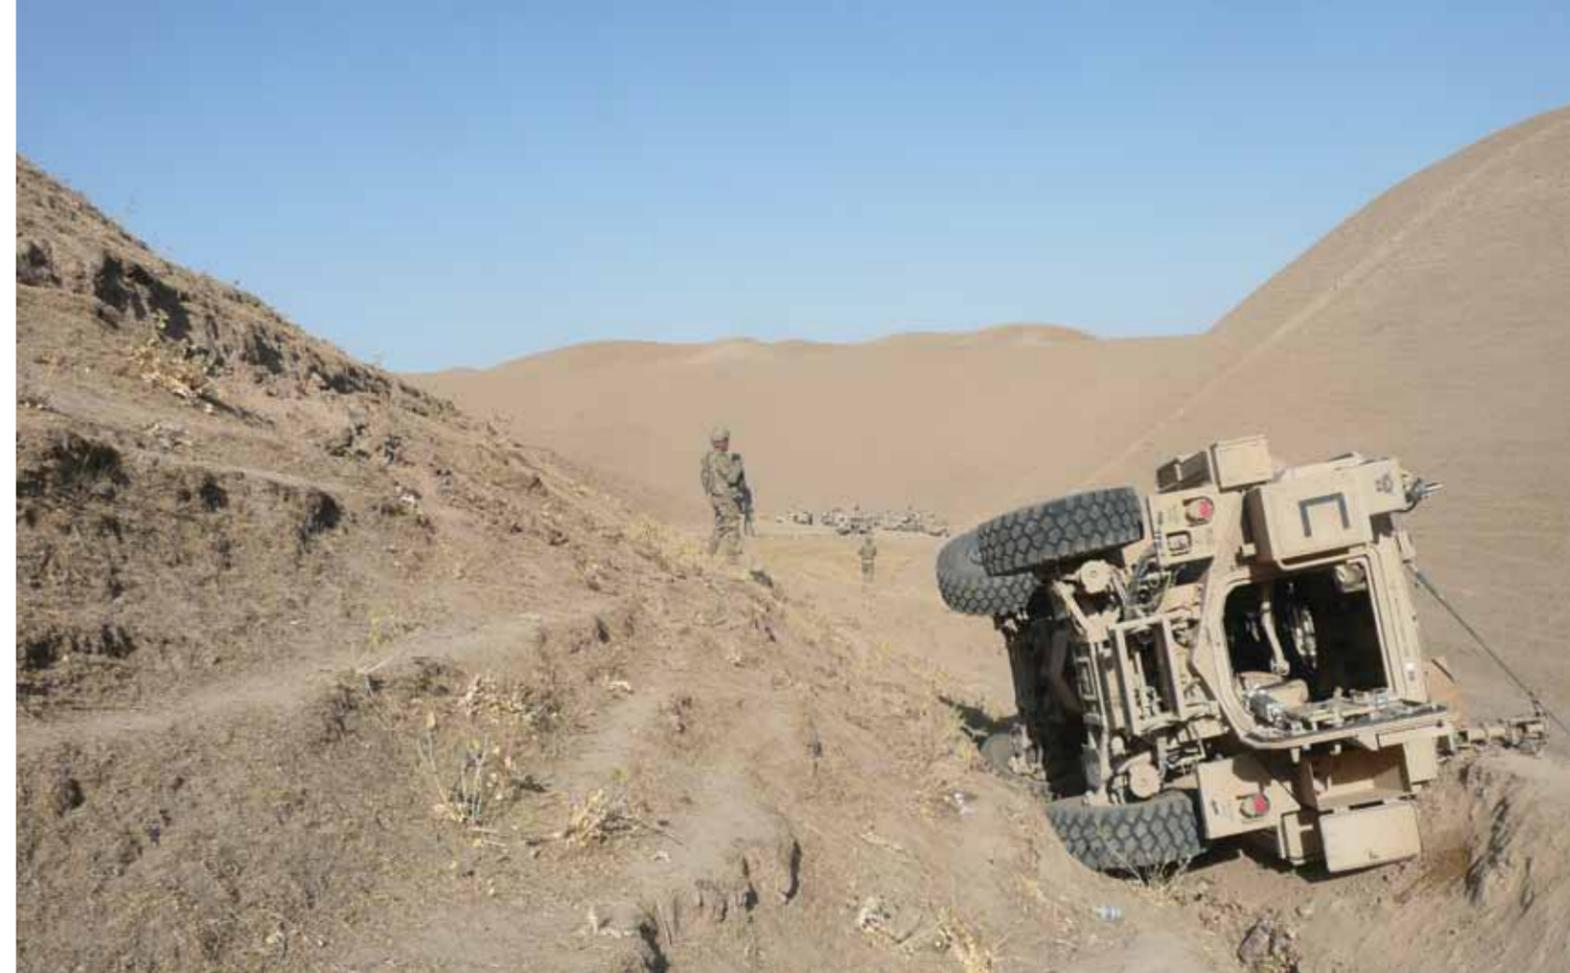
B Company's recovery team conducts an initial survey of the recovery site of a rolled RG-31 MRAP.

the front axle was bent, the rear axle appeared to be intact. The team conducted a 360-degree assessment of the vehicle, evaluated various connection points, and then developed an initial course of action.

The basic plan called for using the MRV's boom to lift the RG-31 out of the ditch where it was wedged, while the HEMTT winched it forward from a lower position. They would then work it laterally along the hillside until it eventually made it back onto the road. The plan may very well have worked, but the team never got a chance to try.

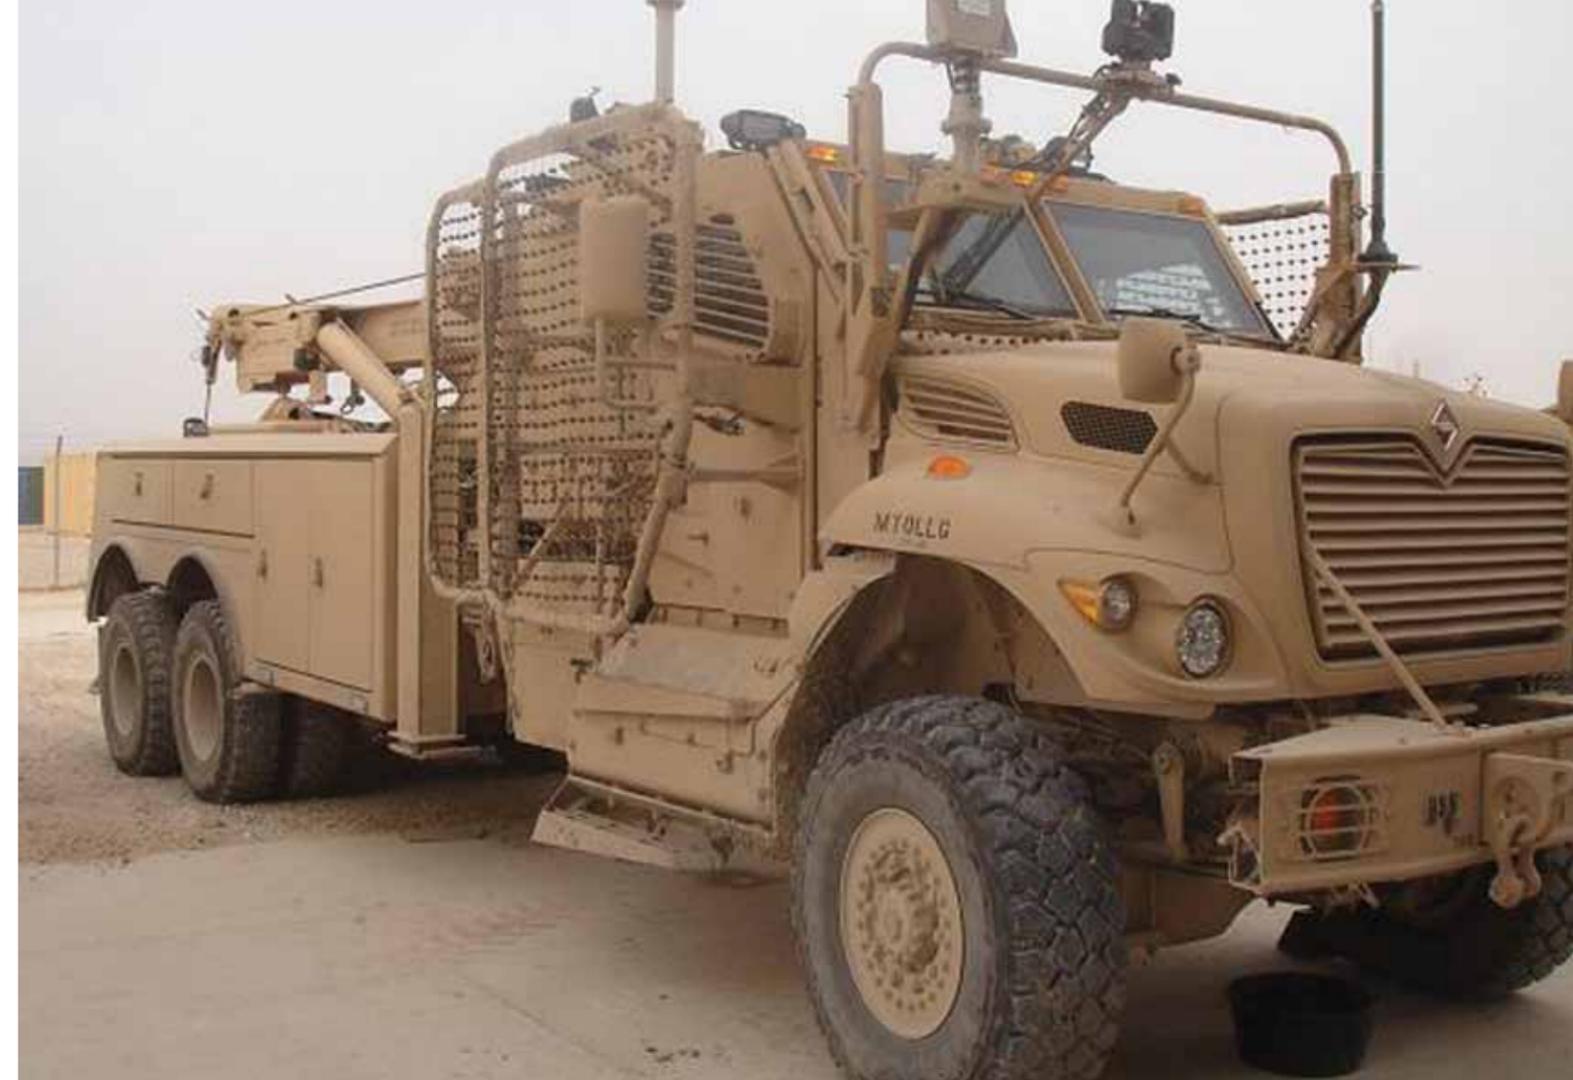
Weighing more than 58,000 pounds, the mine-resistant ambush-protected (MRAP) recovery vehicle (MRV) spans 34 feet between its front and rear axles. Its enormous size made it difficult to drive the vehicle on the roads to get to an MRAP rollover site near a remote road in Afghanistan. The MRV that was used in the recovery mission did not have the "rocket-propelled grenade net" fixed to the cab. With this attachment, the MRV would not have been able to fit on the narrow trail.

Built around a 30-ton lifting boom, the business end of the MRV also includes an impressive set of 25-ton recovery winches and a 50-ton drag winch. Powered by an International DT 9.3-liter, 375-horsepower engine, the MRV weighs roughly 58,200 pounds, giving it an optimum power-to-weight ratio of 1 to 155.2 compared to the HEMTT's 1 to 77.6.

The MRV's wheelbase, an early concern for recovery crews, spans 408 inches between front and rear axles, with only 10 inches of differential ground clearance, making the possibility for bottoming out on uneven terrain seem high. However, for highway operations supporting logistics convoys and route clearance packages along Afghanistan's arterial lines of communication, where improvised explosive device strikes have been a constant threat, nothing could feasibly match the capability and survivability of the MRV.

vehicle, the M916. However, in practice, the M916 was not the problem; the MRV was. Struggling on many of the hills, the MRVs International DT engine showed its limitations. The vehicle also took a beating as it hit repeated dips and potholes, bottoming out numerous times. The crew described the ride as being somewhat reminiscent of a boxing match—they just kept taking hits. It all nearly came to a dramatic halt when the MRV failed five times to surmount a steep hill. Finally, after a running start, the MRV cleared the crest and rocketed over the far side. The mission continued.

The MRV suffered a total power takeoff failure, leaving anything attached to the internal hydraulics system, including the lifting boom, inoperable. [Power takeoff refers to using power from an operating power source, such as a running engine, to operate an attachment, such as the MRV's boom.] Rather than lifting the RG-31 out of its trap, the MRV became a 29-ton roadblock, guarding the hill against the meandering trail of herders and nomads who passed by at frequent intervals.

The reliability of the MRV, like many new Army systems, came into question. Weeks later, after hours of troubleshooting by Army mechanics and field service representatives, the source of the power takeoff failure was found to be a simple fuse, which had been knocked loose in the rough drive into the Sayed valley.

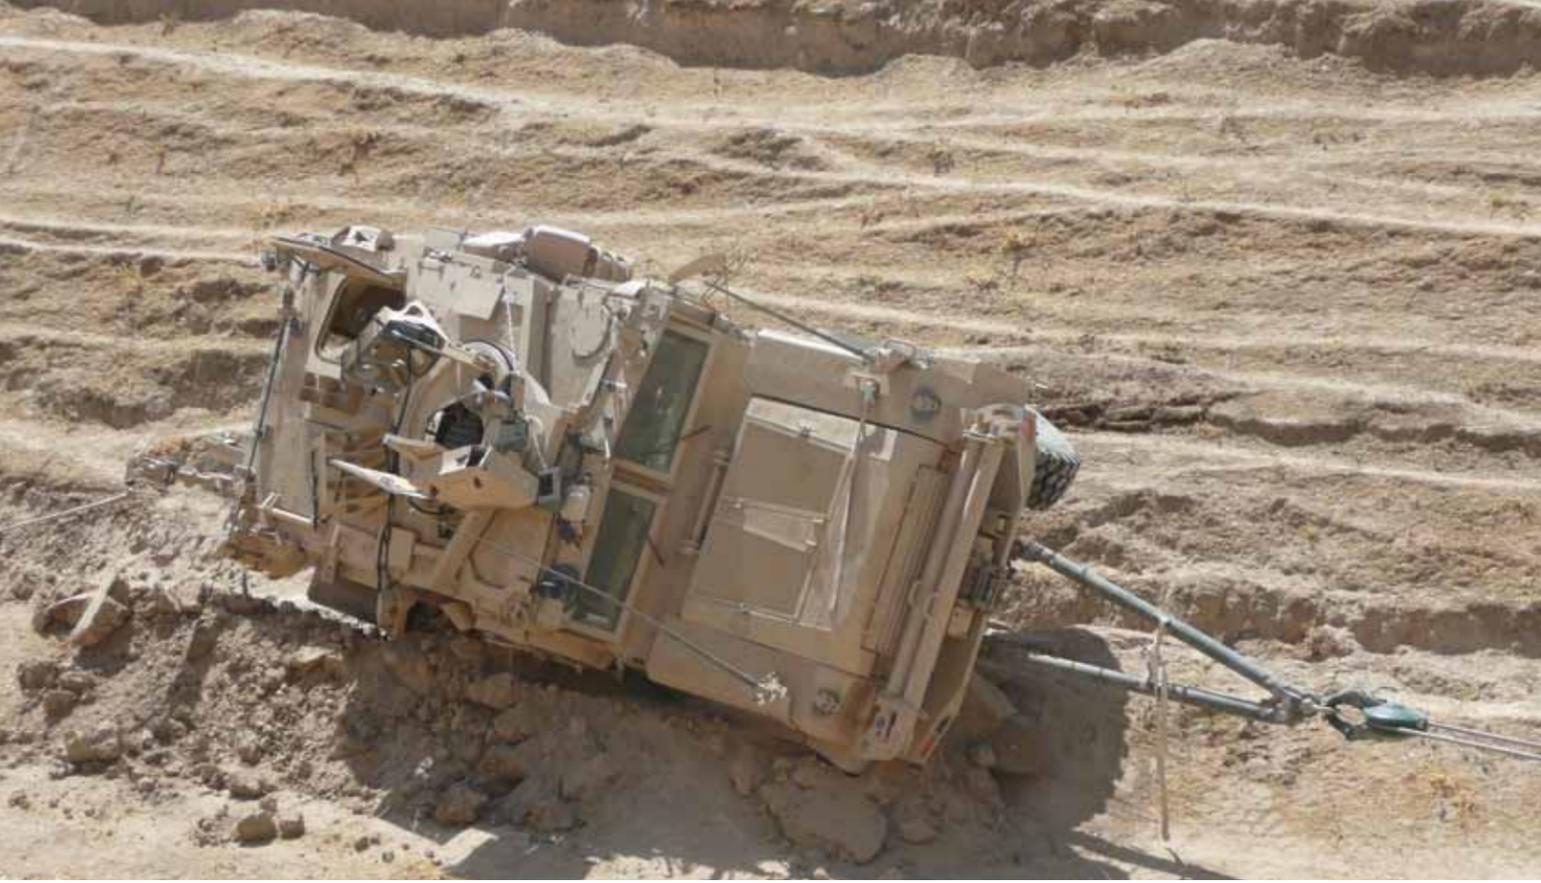
After hours of attempting more delicate procedures to remove the vehicle, the recovery team resorts to pulling the RG-31 from the ditch using a heavy expanded-mobility tactical truck's winch and a 60-ton snatch block.

The first efforts to drag the RG-31 from a low angle showed some progress, but the truck was still dug deeply into the ground. The recovery crews relented and pulled out their “ace in the hole,” the 60-ton snatch block.

Although the snatch block was certain to give the HEMTT enough mechanical force to winch the RG-31 free, the recovery team was concerned about damaging the truck in the process. Having deemed use of the flatbed inadvisable given the terrain, the only legitimate hope of getting the RG-31 out of the valley was to tow it behind the HEMTT. For that to happen, the rear axle had to be preserved. (The front axle was already snapped in half and the right-front tire folded under the chassis.)

To minimize the risk of added structural damage, the team hooked up the towing winch high on the RG-31, hoping to roll the truck out of the ditch and onto the valley floor. This still risked bending or breaking the rear axle; however, the chance of the vehicle landing upright was almost as good. Time and the tools available left little in the way of alternatives.

The RG-31 was hooked up to the HEMTT, with the drag winch cable looped through the snatch block theoretically doubling the winching capacity. Slowly and steadily, the HEMTT pulled on the RG-31. Rock and soil began to shake loose, and the MRAP began to move forward, breaching the top of the ditch in a plume of dust as hundreds of pounds of earth gave way. Cresting the ditch, the RG-31 pitched nose down and slid into the valley, surprisingly enough still on its side.
